CHURCH HILL WILMINGTON CONSERVATION AREA APPRAISAL

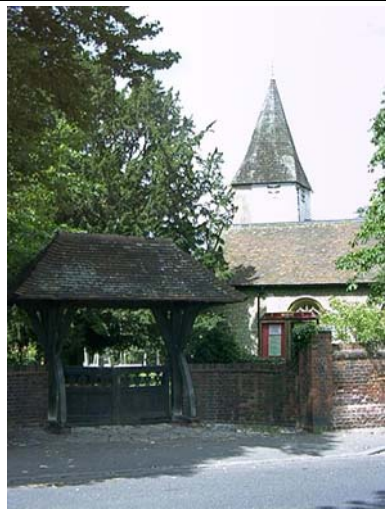
Figure 1- St. Michael and All Angels Church

area. There has been a place of worship on the site from at least Saxon times (Figure 1). The Church has been extensively changed over time and includes

mediaeval, Saxon, and even some Arts and Crafts alterations. Coombe Cottage is one of the few properties in the village set within it's own grounds (Figure 2). Prior to 1850 when Wilmington School was opened, a Dames school for elementary education was held at Coombe Cottage. It was the first voluntary school in the area, prior to the introduction of compulsory education.

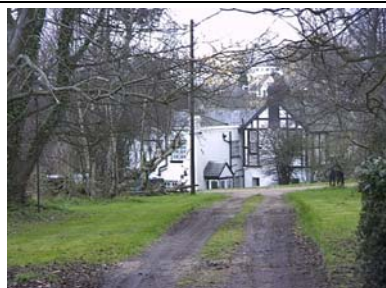
Figure 2- Coombe Cottage

Subsequently, Coombe Cottage became the residence of the curate of St. Michael and All Angels Church. The path between the cottage and the church is known locally as "Curate's Walk".

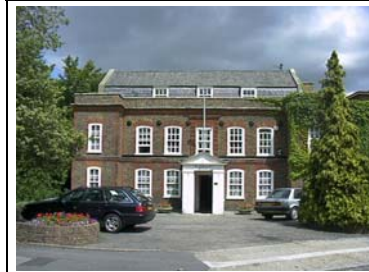
Figure 3- Wilmington House

The building of Wilmington House (Figure 3) early in the C18th, together with the attendant land incorporated in the grounds, protected the local area from major development in the intervening years. However, in the mid 1930's the grounds to the front of the house, which included the lodge and stable buildings, were sold for development. A contemporary planning application (Figure 4) shows the formation of Church Walk. Examination of other planning applications for the houses along Church Hill show that the whole site developed rapidly.

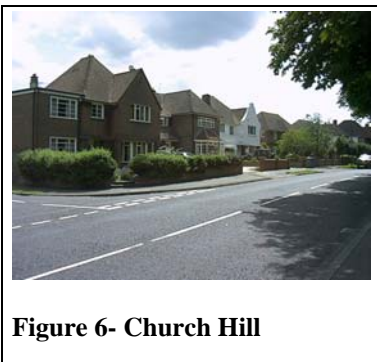
Figure 6- Church Hill

relatively unique to its neighbour (Figure 6, 7 and 8). In Church Walk, the style is more homogenous, although again each house has unique features (Figure 7 and Figure 8). Much of the housing in the Conservation Area was developed in the mid to late 30's, by Cooper Estates Ltd,

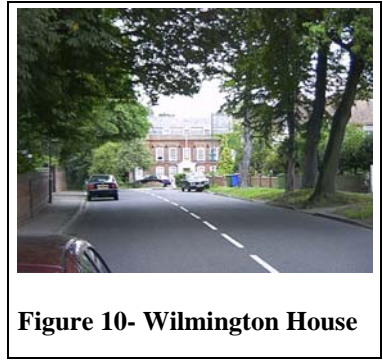
Figure 10- Wilmington House

Wilmington House offers a strong visual stop to the vista travelling east from Wilmington (Figure 10). This may have been a deliberately contrived vista when the House was built since it is on the axis of the road. The historic building itself is of good quality and Grade II listed. Unfortunately the building has lost its setting over the years. Apart from the vista along the road, there is no real sense of the original layout of the estate. Wilmington House is currently used as offices. The extensions carried out in the 1950's, 60's and 1970's are of simple design

Wilmington House is built in fine red brick and has classical Georgian proportions, complete with a pedimented portico. The modern extensions are of simple 'brick box' design in a contrasting brick to Church Walk. The major extension to the side and rear of the House now practically subsumes the original building at the rear, and forms a major part of the public elevation in Church Walk.

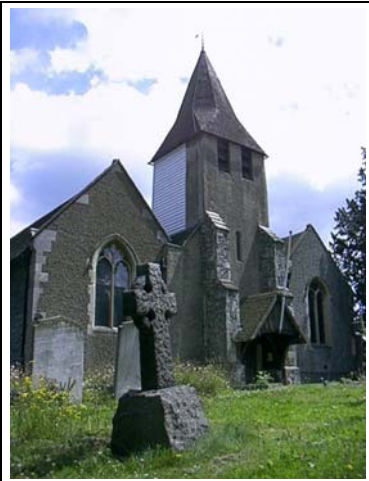
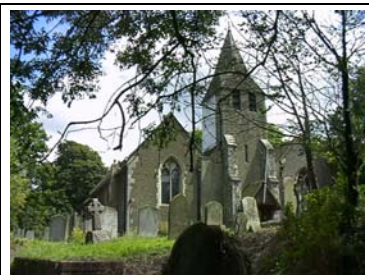
The graveyard has a tranquil air away from the bustling Church Hill, and from within the graveyard there are fine views of the church (Figures 11 and 12). The precincts around the church are defined as an area of archaeological potential due to the antiquity of the use of the site.

St. Michael and All Angels Church has a wealth of varying materials including knapped flint with stone dressings, render

and even timber weatherboarding to the spire.

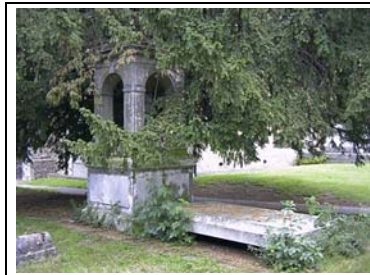
Figure 13- Hulse Memorial

St. Michael and All Angels has all the requisite qualities of a fine local church. There are four important tombs and memorials within the yard, although some are in need of repair. These include the Hulse Memorial dated 1795, (Figure 13) and the Russell family vault dated 1852 (Figure 14). The fine yew tree over the Hulse Memorial is several hundred years old.

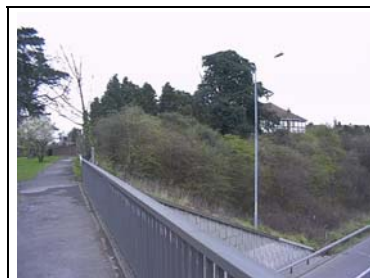
Figure 15- A2 Boundary

As a complete contrast, the A2 trunk road marks the southern boundary of the Conservation Area. The A2 forms a very strong sound and visual barrier to the remaining part of the High Road. The boundaries of the properties adjacent to the A2 form a natural line to the

boundary of the Area (Figure 15).
